HOUSATONIC RIVER BASIN
DERBY, CONNECTICUT
LOWER ANSONIA RESERVOIR DAM
CT 00027

PHASE I INSPECTION REPORT
NATIONAL DAM INSPECTION PROGRAM

SEPTEMBER, 1980

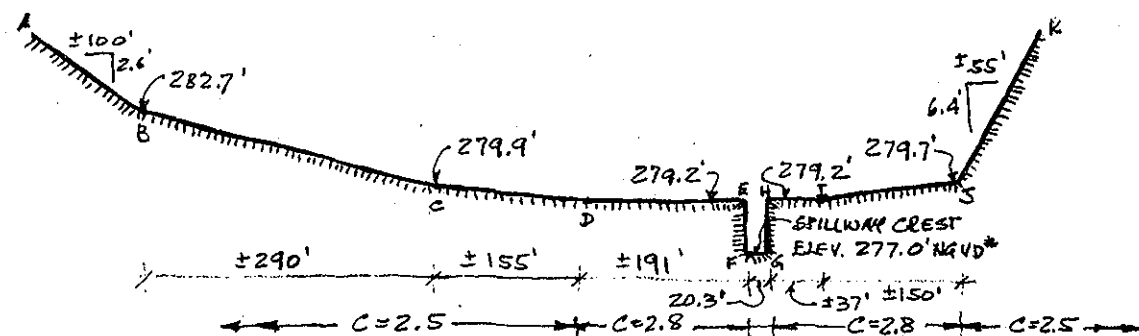
LOWER ANSONIA RESERVOIR DAM
APPROXIMATE OVERFLOW PROFILES

DATA FROM THE ANSONIA WATER CO. DWG. "PLAN AND ELEVATION OF DAM AT THE LOWER RESERVOIR OF THE BIRMINGHAM WATER CO." AND C.E. OBSERVATIONS ON 5/28/80 BY WHL & R.J.

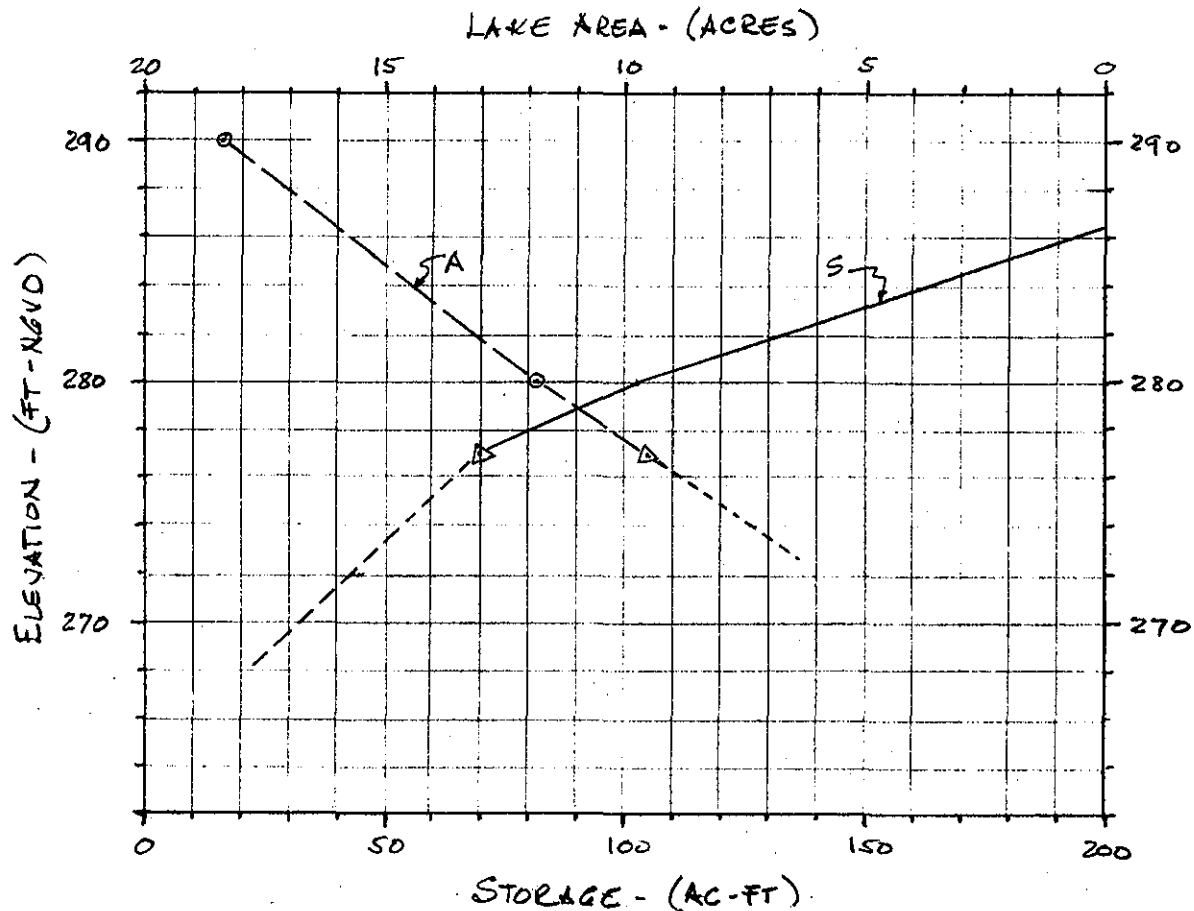
A) RESERVOIR AREA/STORAGE CURVES - LOWER ANSONIA RESERVOIR

△ DATA FROM ANSONIA WATER CO. DWG. "RESERVOIR N°1" (FILE N° 276T-27-FF1)

○ AREAS FROM USGS ANSONIA, CT. QUADRANGLE SHEET (REV. 1972)
